Are You Really Getting What You're Paying For?

"Airing" Our Grievance: Why More Air is a Problem

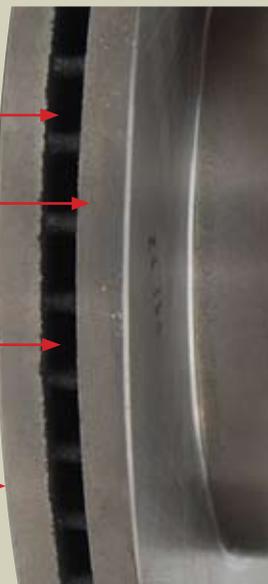
RAYBESTOS ROTOR

COMPETITOR ROTOR

AIR GAP MATCHES OE

Properly dissipates and absorbs the heat

PLATE MATCHES OE

Maximum rotor life; can be machined; resistant to premature "warping"

VANE SIZE MATCHES OE

Maximized cooling and proper harmonic design reduces brake noise

MATERIAL MATCHES

OE SPECIFICATIONS (G3000)

AIR GAP INCREASED

Leads to "warped" rotors

THINNER PLATE

Increases the likelihood of heat checking and can lead to premature failure

VANE SIZE CHANGES

Reduced vane size can lead to early product failure

COST SAVING MATERIAL CHANGES

Inhibits noise reduction capabilities and causes brittleness (G2500)

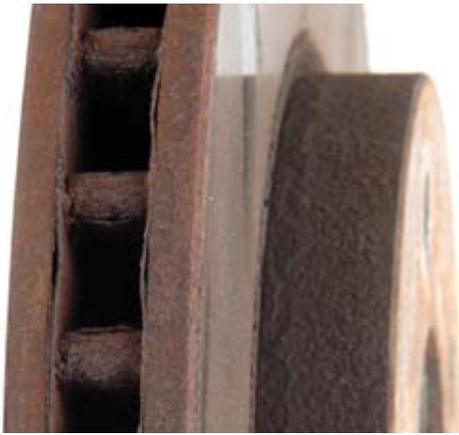
ROTOR WITH SEVERE RUST IN THE VANES

In severe climate conditions where rust is prevalent and vane dimensions have been reduced, the deterioration rate of the vanes can be accelerated with exposure to salt or calcium chloride commonly used in winter road conditions. Such conditions, combined with reduced vane sizes, can seriously reduce rotor life while simultaneously increasing the potential for failure.

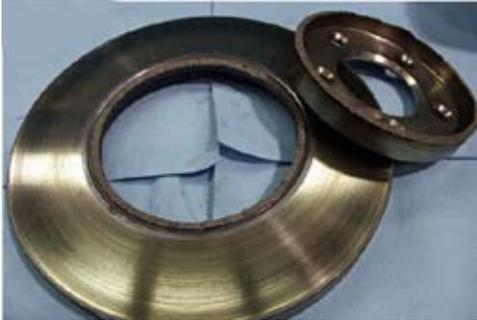
EXCESSIVE HEAT CAUSES CASTING FAILURE

In addition to plate gap variations, Raybestos is seeing dimensional changes and reductions in “lightweight” competitors vane configurations. The reduction in vane mass causes material strength to decrease at the vane/surface plate interface and can lead to the possibility of early product failure.
